TEST REPORT

Report No...... : P17021-17

Test item description..... : LED Controlgear

IP Code : IP67

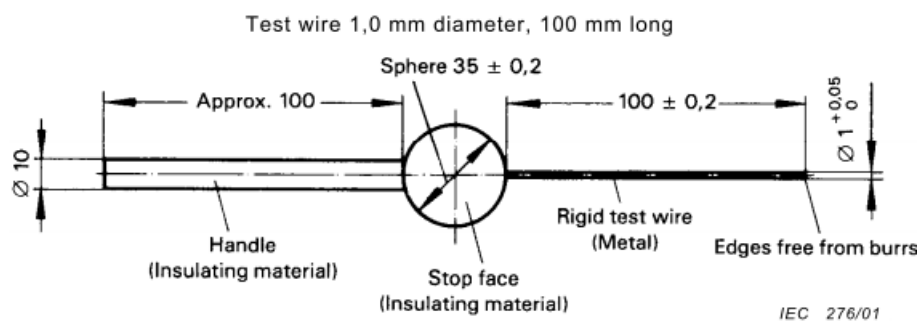
Use specified test probe below with a force of $1\text{ N} \pm 10\%$ to push against any opening of the enclosure.

The test result was considered acceptable since the access probe did not touch hazardous live parts.

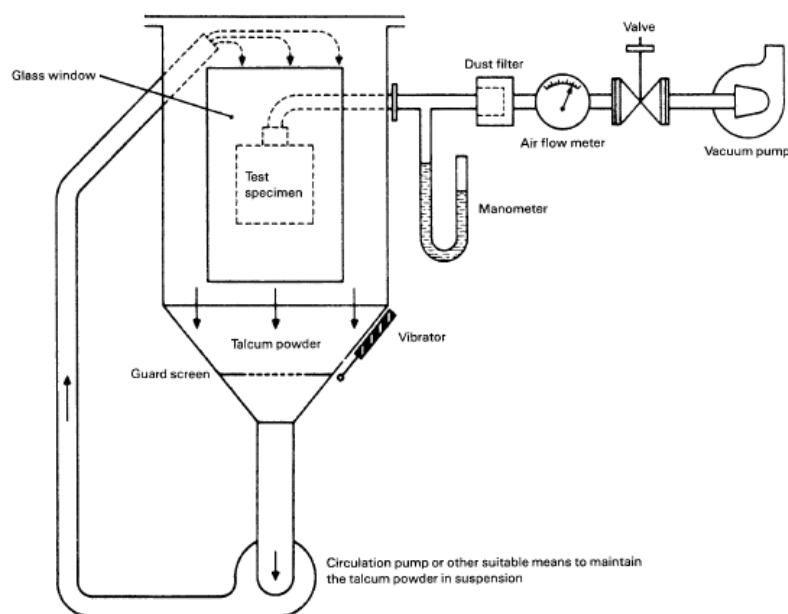
Figure 2 – Test device to verify protection against dust (dust chamber)

The test was made using a dust chamber incorporating the basic principles shown in figure 2 whereby the powder circulation pump may be replaced by other means suitable to maintain the talcum powder in suspension in a closed test chamber.

The depression did not exceed 2 kPa (20 mbar) on the manometer shown in figure 2.

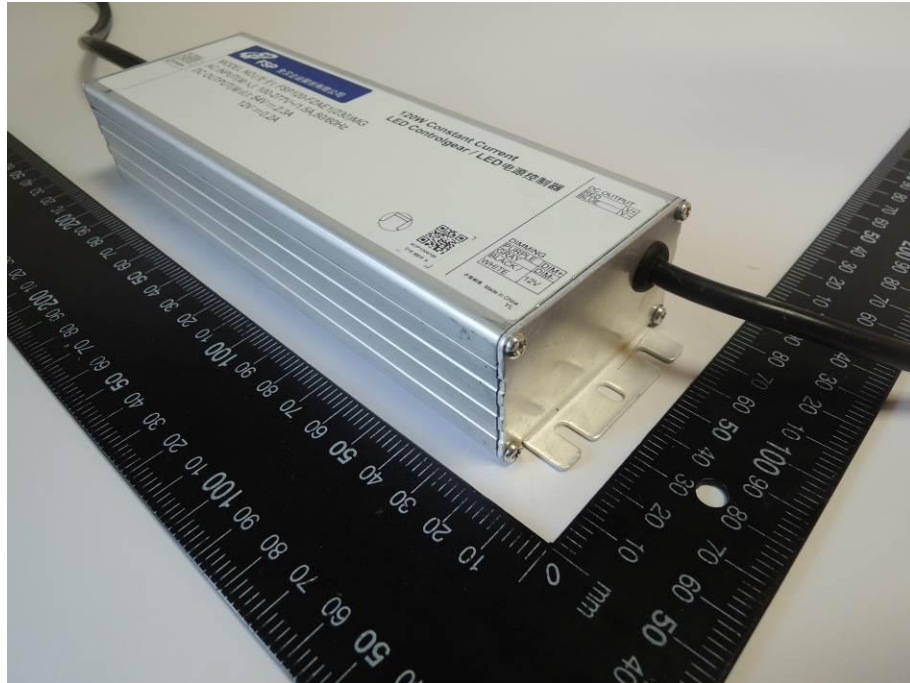
Overall View 1 of model FSP120-FZAE1(230)MG

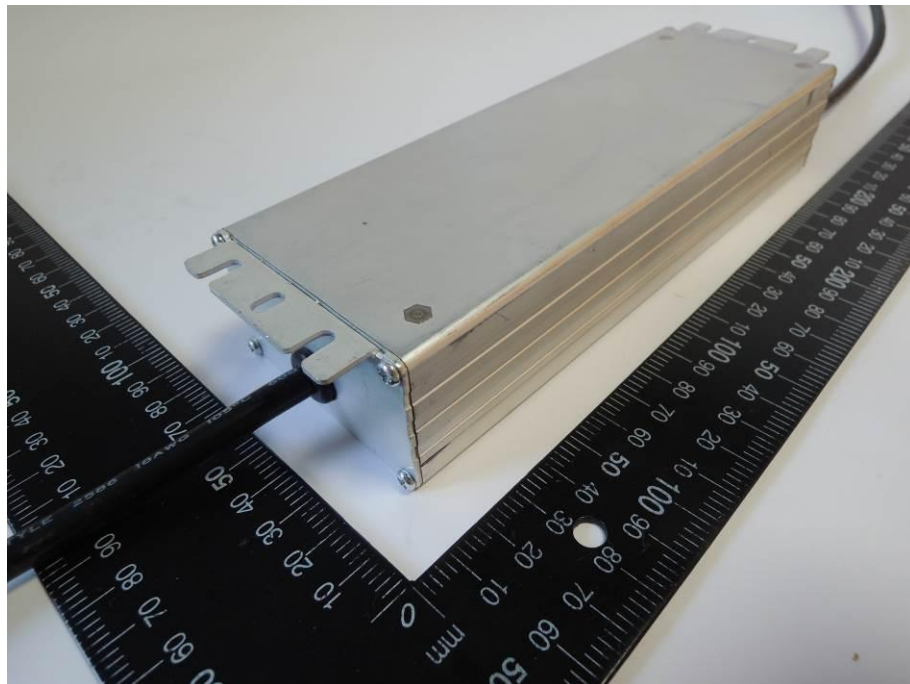
Overall View 2 of Model FSP120-FZAE1(230)MG

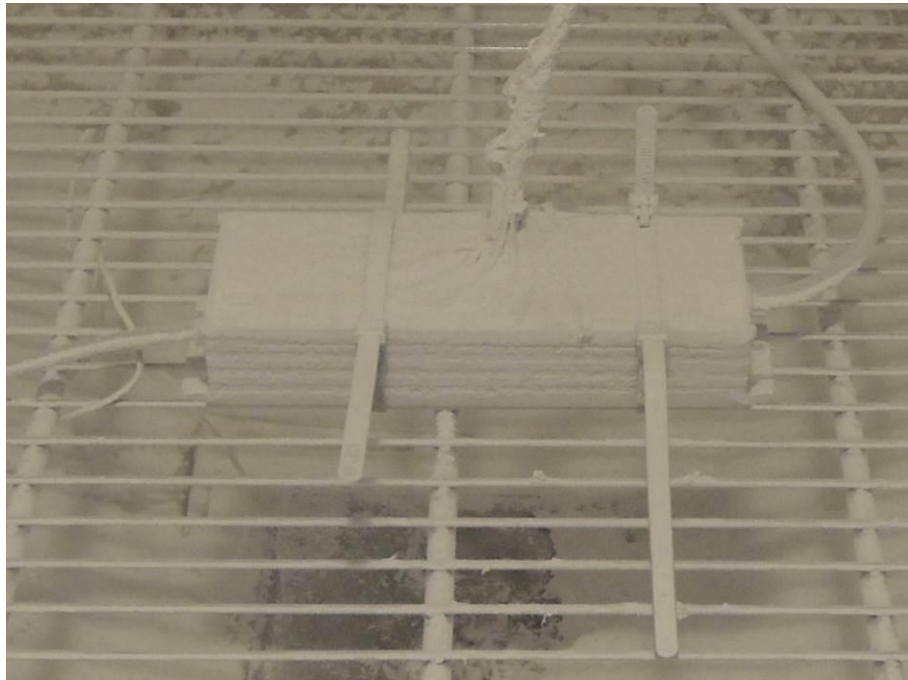
View of Model FSP120-FZAE1(230)MG under IP6X Testing

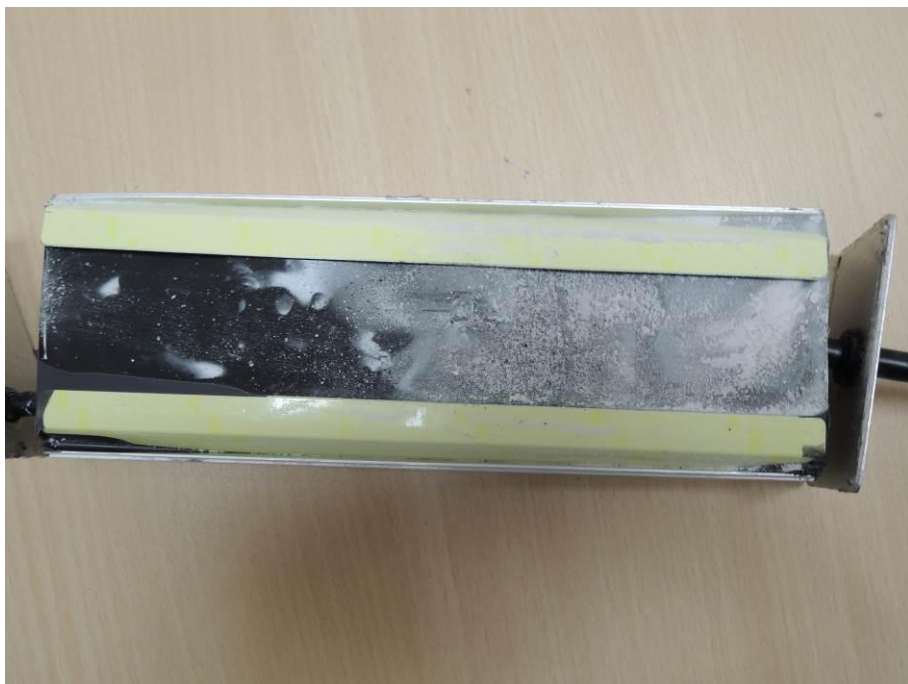
View of Dust Found on Outer Box and Internal Potting Compound of Model FSP120-FZAE1(230)MG after IP6X Testing

Model	Sample No.	Observations
FSP120-FZAE1(230)MG	3	The dust was found between outer box and internal potting compound, but was not found in the cord or on components

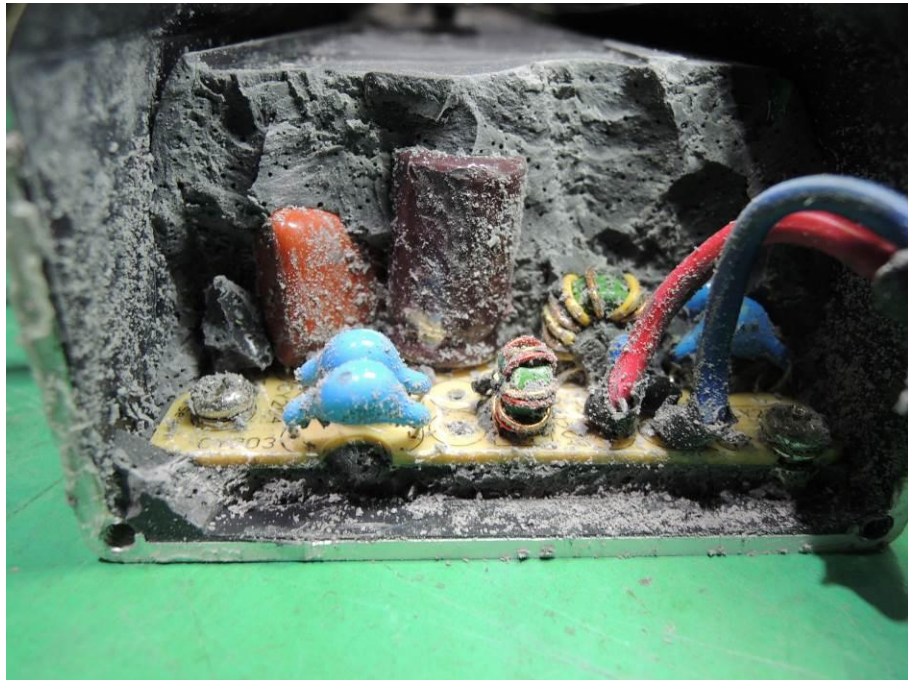
Internal View 1 of Model FSP120-FZAE1(230)MG after IP6X Testing

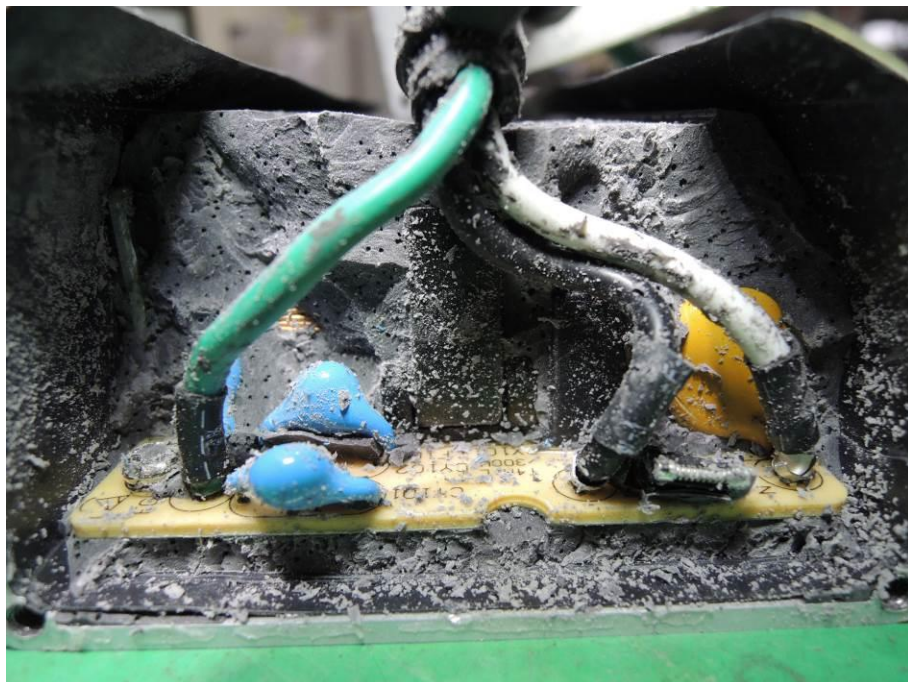
Internal View 2 of Model FSP120-FZAE1(230)MG after IP6X Testing

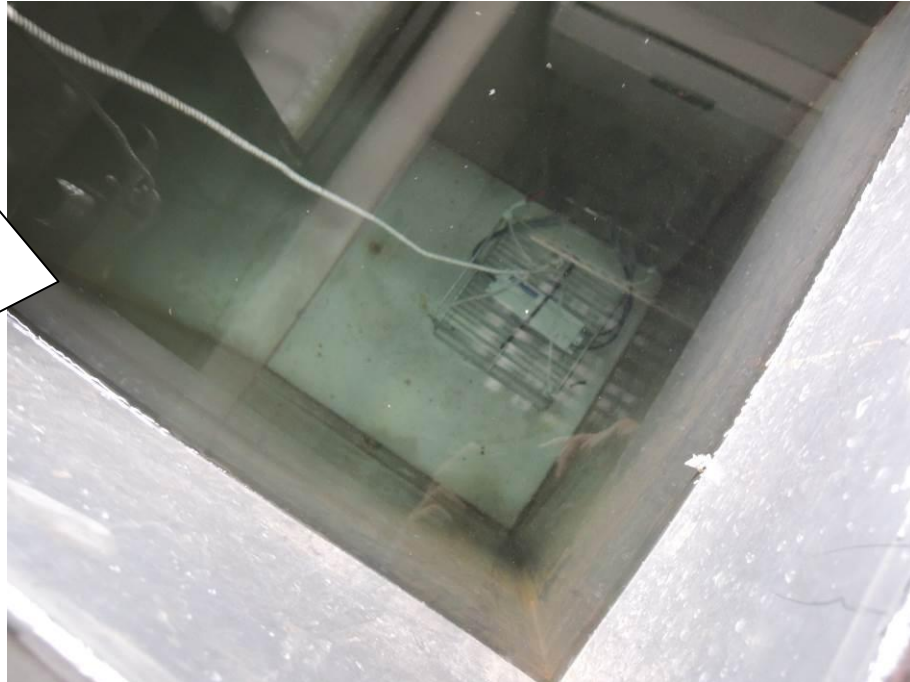
View of Model FSP120-FZAE1(230)MG under IPX7 Testing

1 m Depth from The Bottom of Chamber to Water Surface

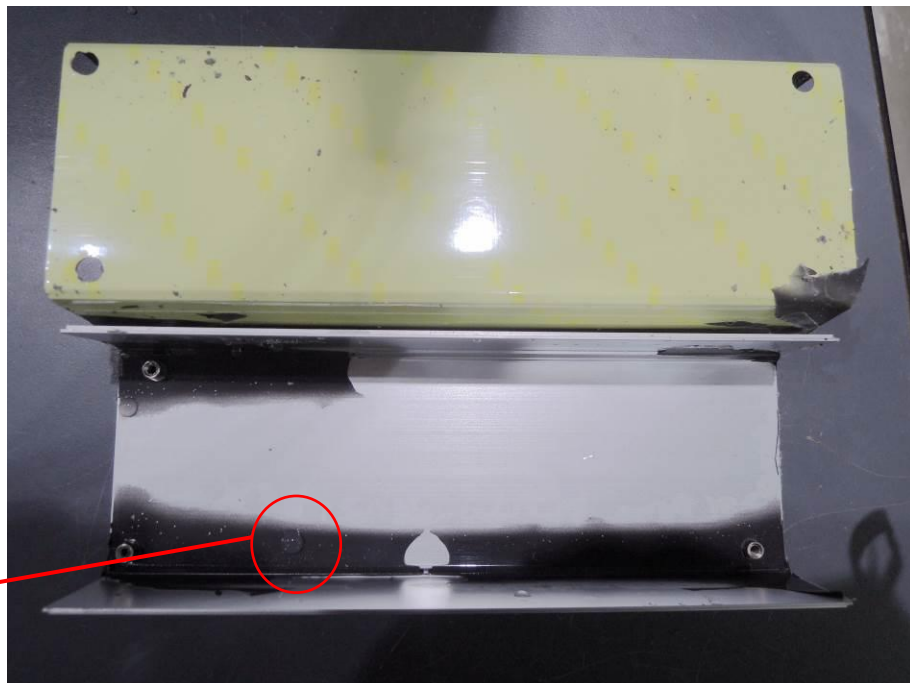
Ingress of Water

Internal View of Ingress of Water between Outer Box and Internal Potting Compound Model FSP120-FZAE1(230)MG after IPX7 Test

Model	Sample No.	Observations
FSP120-FZAE1(230)MG	4	The water was found between outer box and internal potting compound, but was not found in the cord or on components

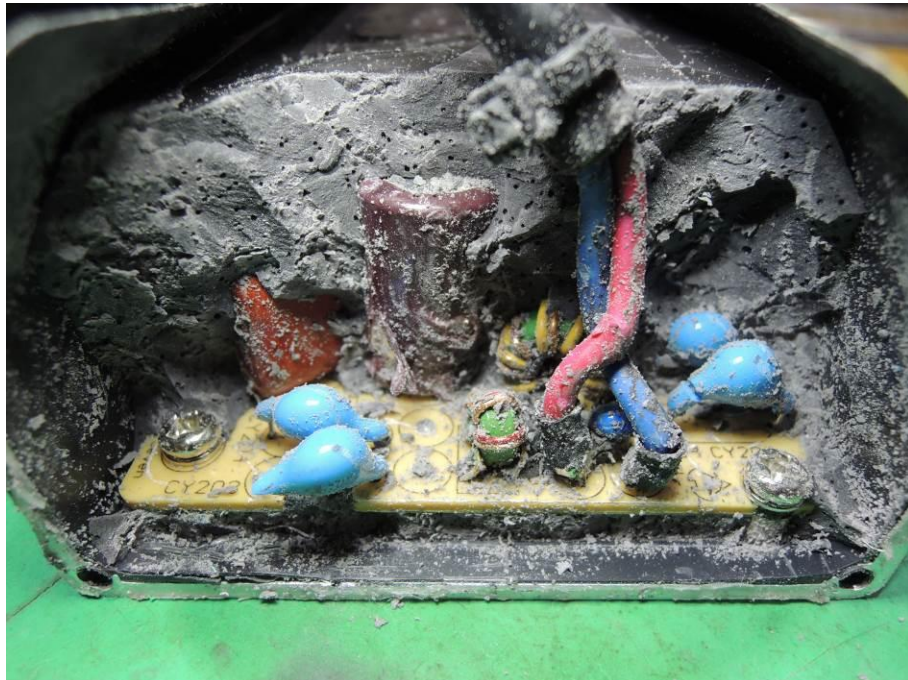
Internal View 2 Model FSP120-FZAE1(230)MG after IPX7 Test

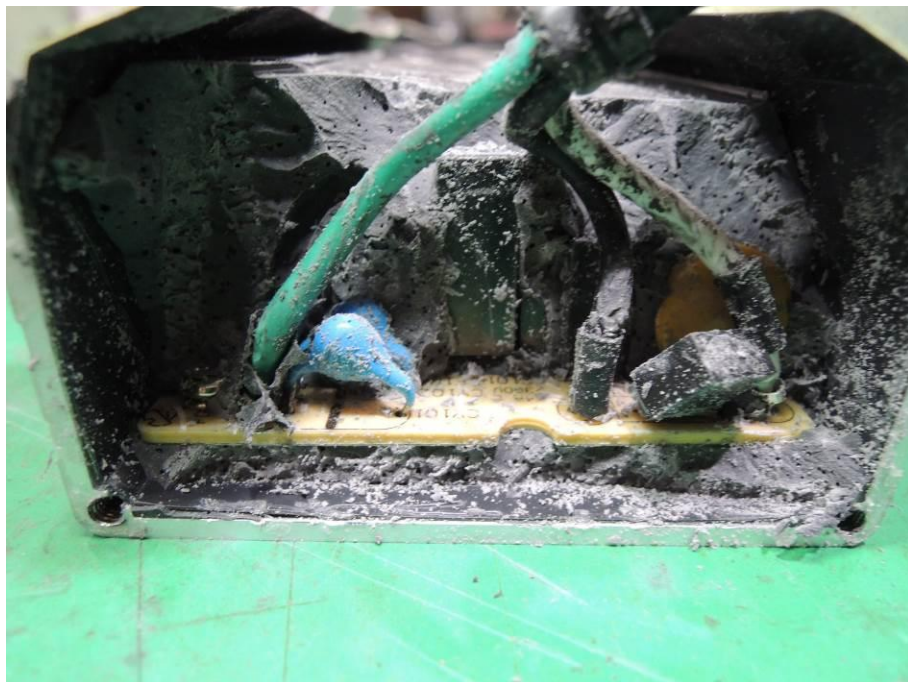
Internal View 3 of Model FSP120-FZAE1(230)MG after IPX7 Test
