TEST REPORT

Report No..... : D22001-19

Standard..... : IEC 60529 (Edition 2.2)

Test item description..... : LED Controlgear

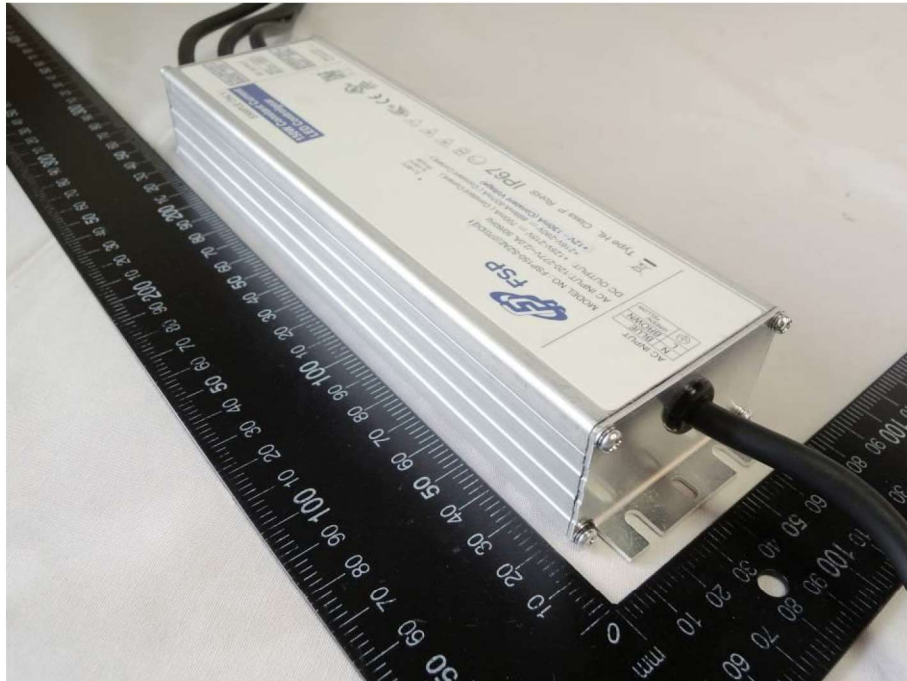
Overall View 1 of Model FSP150-SZAE(070)DG1

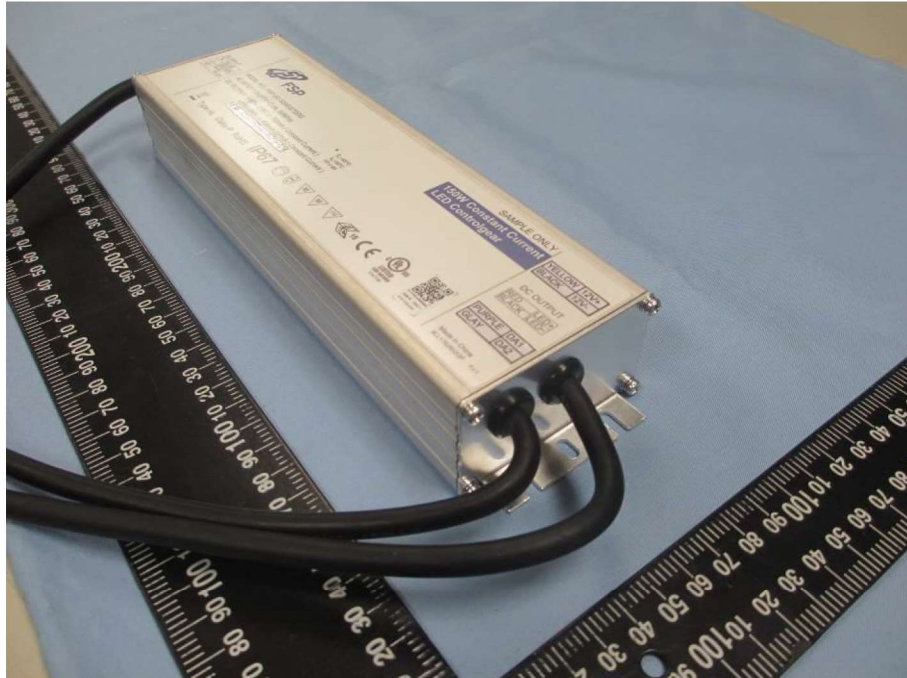
Overall View 1 of Model FSP150-SZAE(070)DG

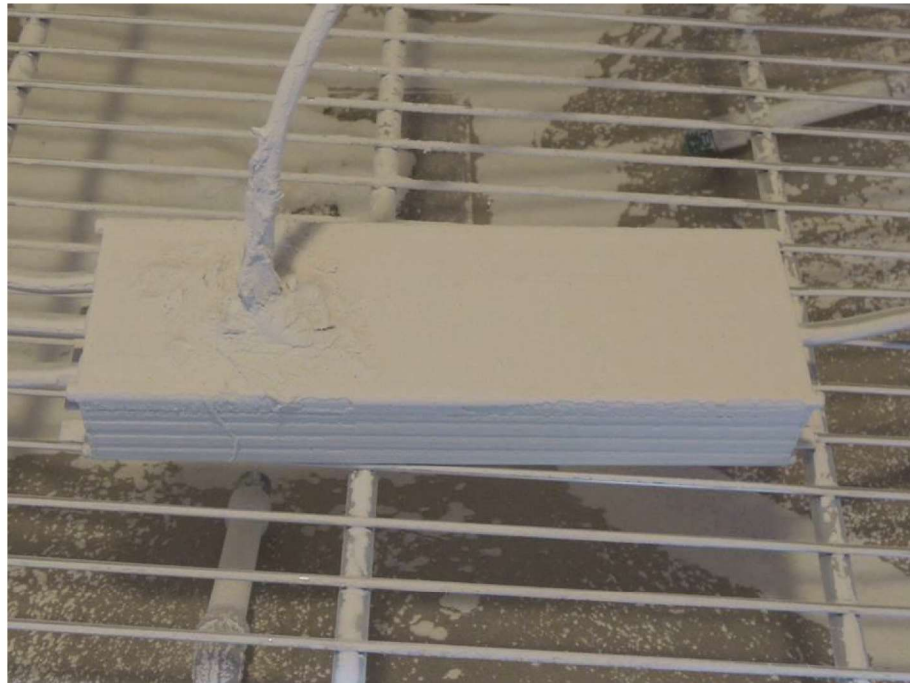
View of Model FSP150-SZAE(070)DG1 under IP6X Testing

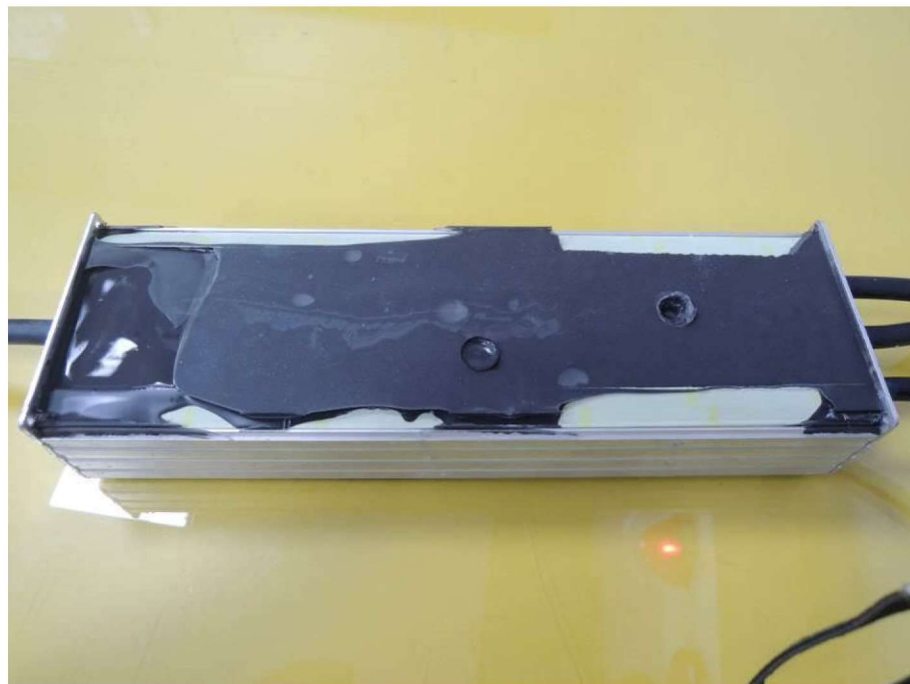
Internal View 1 of Model FSP150-SZAE(070)DG1 after IP6X Testing

The test result was considered acceptable since the dust was not found in the cord or on components after test.

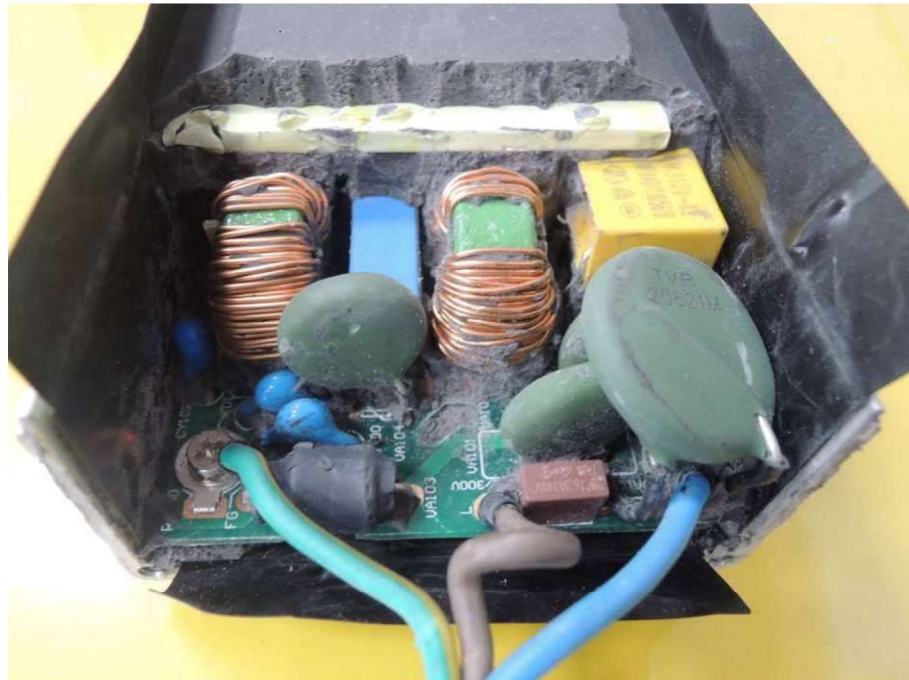
Internal View 2 of Model FSP150-SZAE(070)DG1 after IP6X Testing

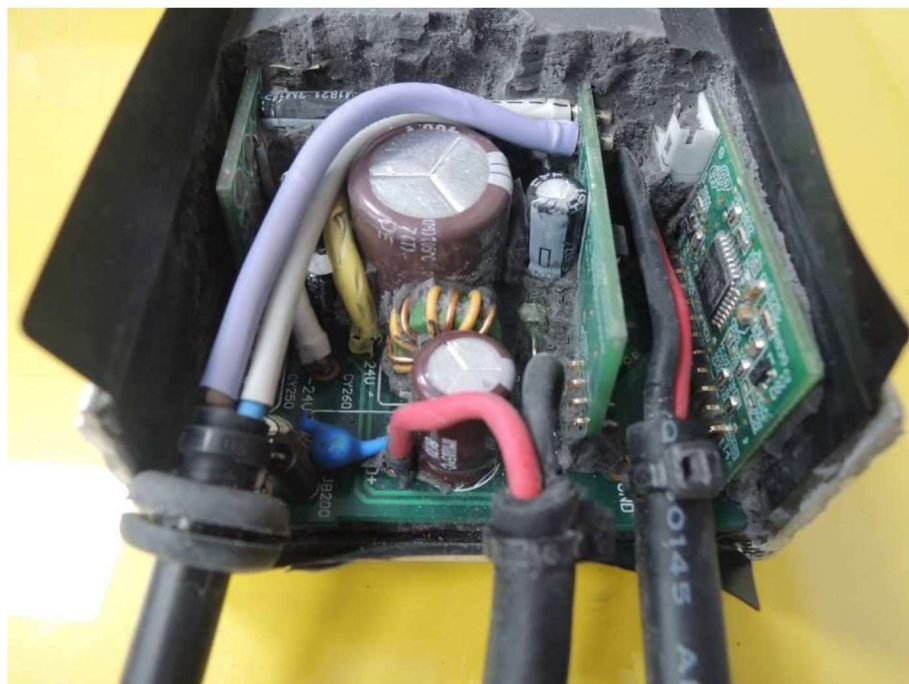
Internal View 3 of Model FSP150-SZAE(070)DG1 after IP6X Testing

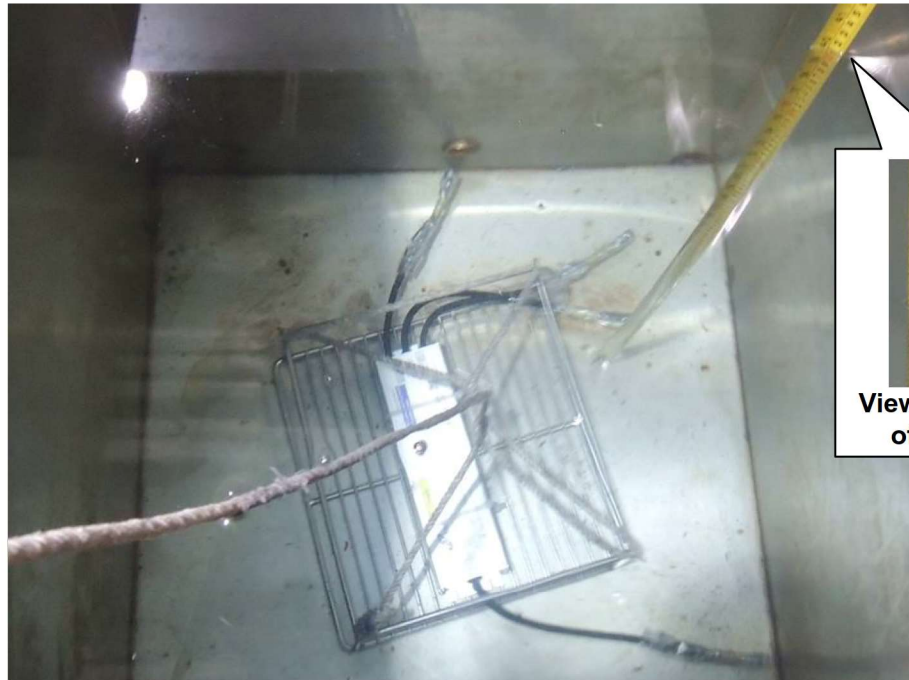
View of The Depth of Immersion

View of Model FSP150-SZAE(070)DG1 under IPX7 Testing

- a) the lowest point of enclosures with a height less than 850 mm was located 1 000 mm below the surface of the water.
- b) the duration of the test was 30 min;
- c) the water temperature did not differ from that of the equipment by more than 5 K.

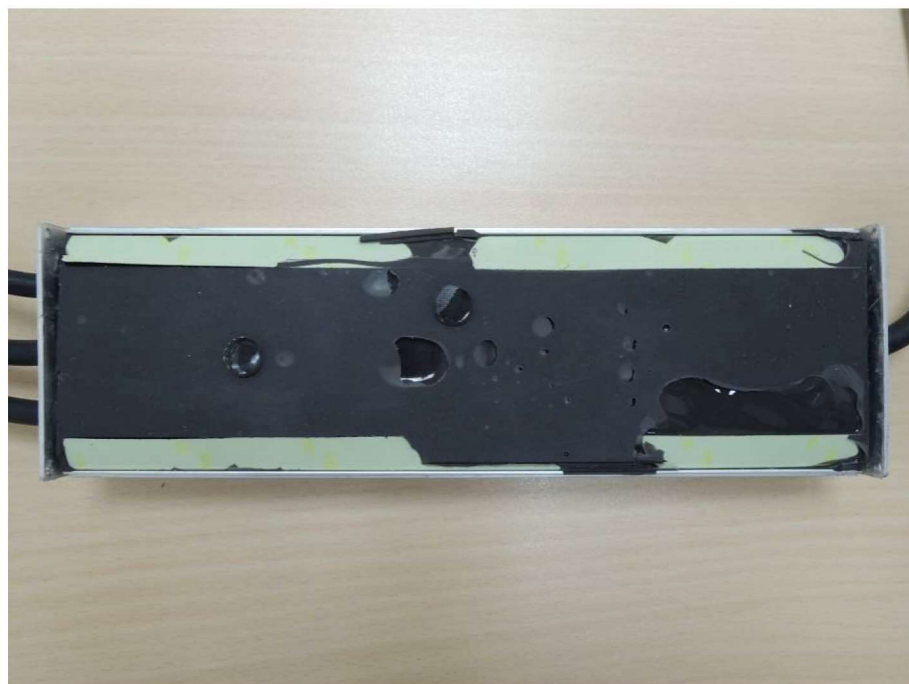
Internal View 1 of Model FSP150-SZAE(070)DG1 after IPX7 Testing

The test result was considered acceptable since no deposit of water was found in the cord or on components after test.
